REUBEN HART RESERVOIR DAM

CT 00096

PHASE I INSPECTION REPORT
NATIONAL DAM INSPECTION PROGRAM

Identification No.: CT 00096
Name of Dam: Reuben Hart Reservoir Dam
City: Torrington
County and State: Litchfield, Connecticut
Stream: Hart Brook
Date of Inspection: 24 October 1978

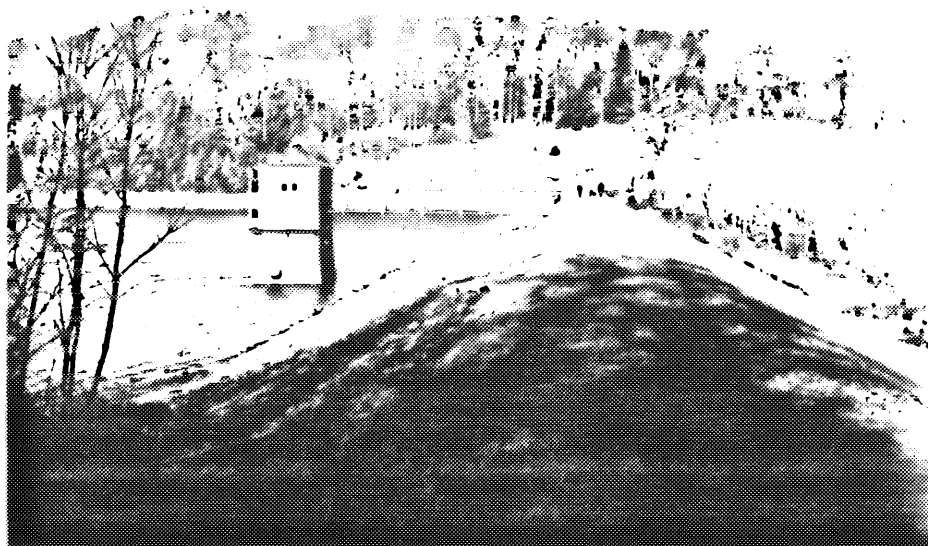
Overview of dam from right abutment.

The horizontal and vertical alignment of the dam embankment is good (Overview Photo, p. viii). The upstream slope consists of hand placed riprap, which is in generally good condition (Appendix C, Photo No. 1). At approximately Sta. 5+40 (Plan, Appendix B) about 6 ft. below the crest of the dam, the riprap has been moved by ice jacking and the grass slope above it has moved downwards slightly. Left of the gatehouse structure the upstream edge of the crest of the dam appears to have settled about 6 in. for a distance of 200 to 300 ft. It may be that this apparent settlement has either been caused by ice jacking of the riprap slope or by differential settlement within the embankment structure. This appears to be a shallow phenomenon and of no major consequence.

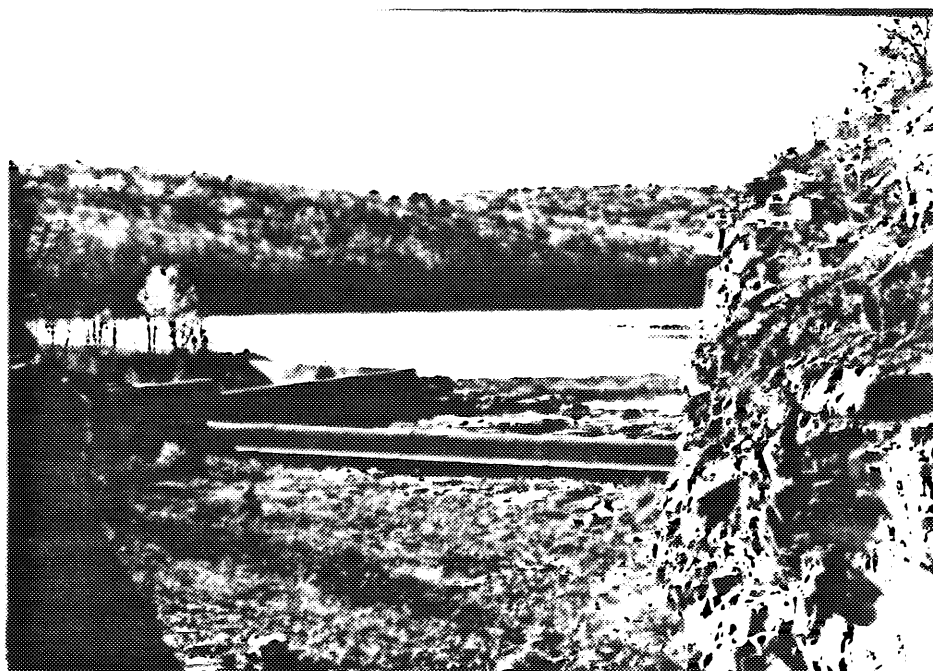
Overview of spillways from downstream chute.

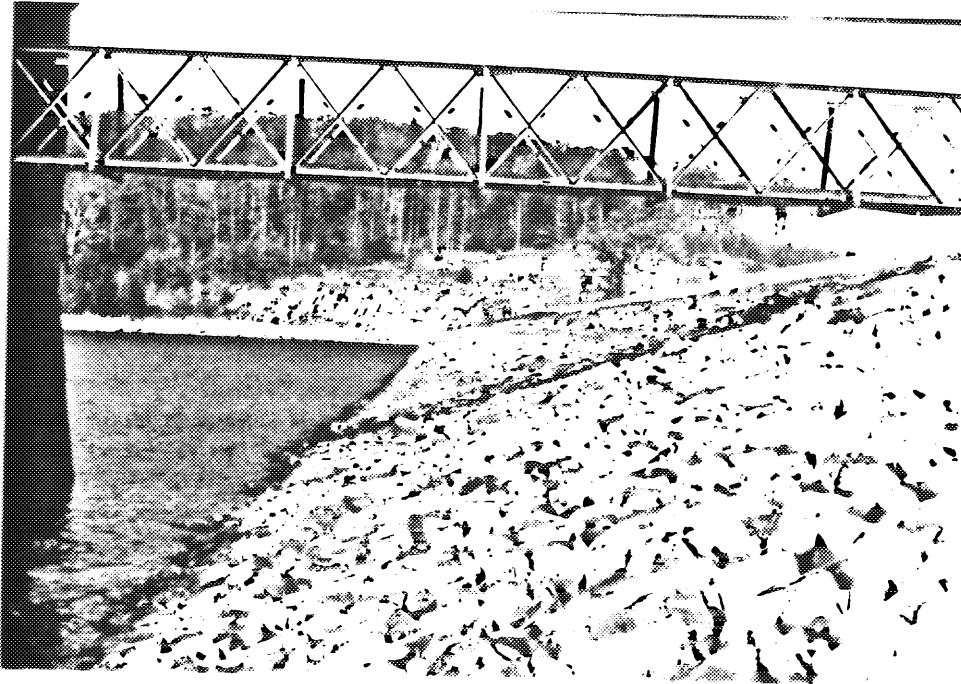
1. Hand placed riprap on upstream slope.

2. The disintegrated concrete at the top of the wall between the service spillway and dam should be repaired.
3. The displaced riprap near the top of the upstream slope between Sta. 4+00 and Sta. 7+00 should be repaired or realigned.

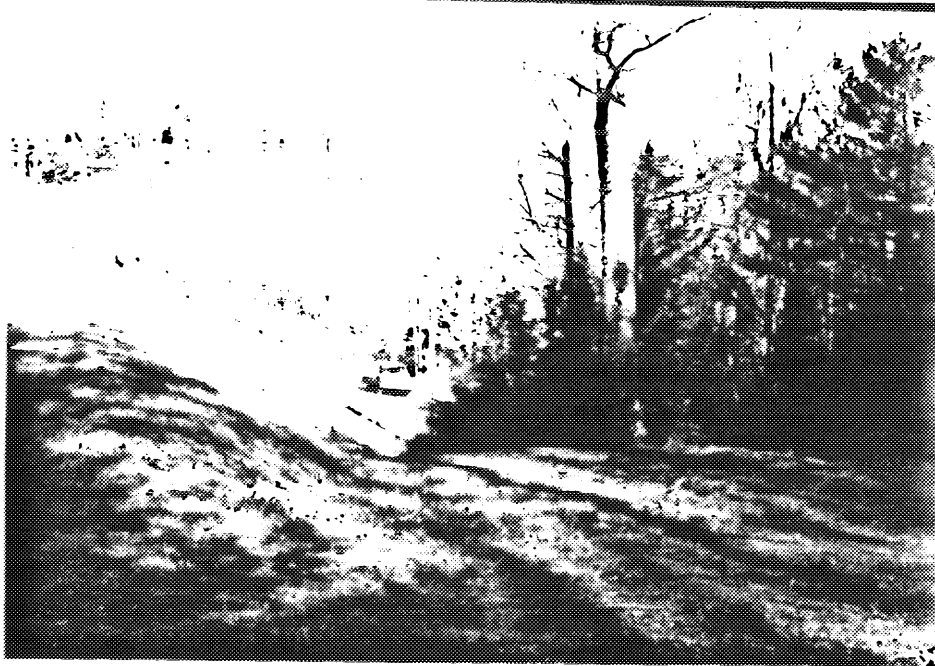
The downstream slope shows no bulges, sags or other evidence of movement, is well maintained and regularly mowed, and generally appears to be in good condition (Appendix C, Photo No. 2). The downstream toe is wet for a distance of about 150 ft. to the left of the 24 in. dia. outlet and valve chamber, but there are no well-defined seepage points or boils. About 80 ft. to the right of the valve chamber there is another wet area extending for about 15 ft. along the toe and 50 ft. downstream normal to the axis of the dam. This area seems to be lower than the general terrain and it may collect some runoff from the slopes forming the right abutment, in addition to seepage from the dam. Farther downstream from this point there is a natural drainage swale which appears to be picking up seepage from the dam, in addition to runoff from the high ground downstream from the right abutment. A small volume of water is also seeping out of the end of the

2. Downstream slope from left abutment.

It is recommended that the owner should retain the services of a competent registered professional engineer to make investigations, studies, and, if proved necessary, to design remedial works to rectify the seepage and wet areas downstream of the toe of the dam.

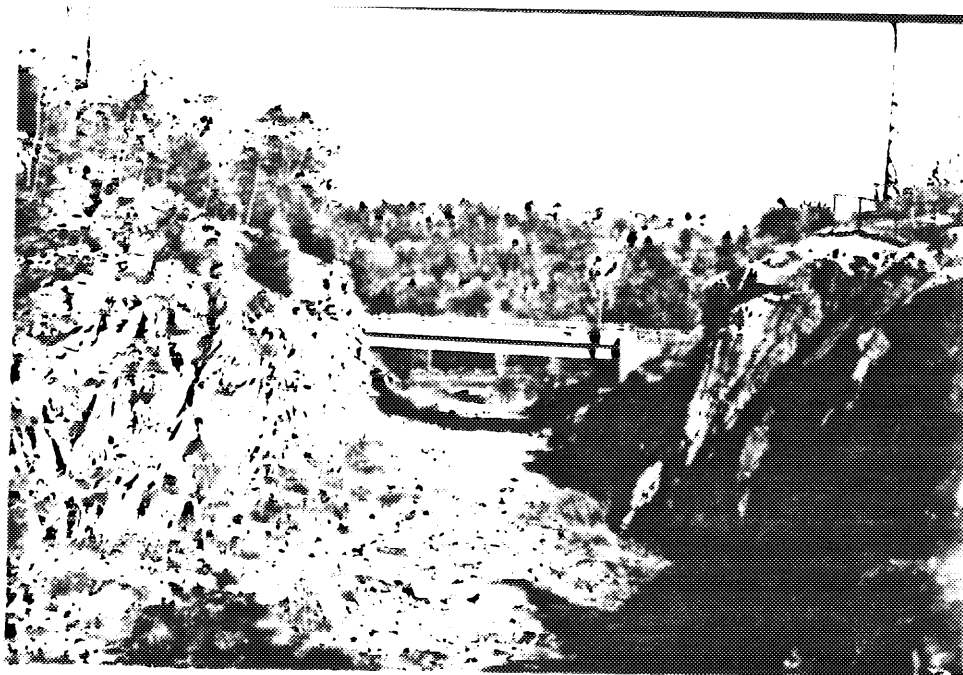
4. Downstream channel and Route 272 bridge.

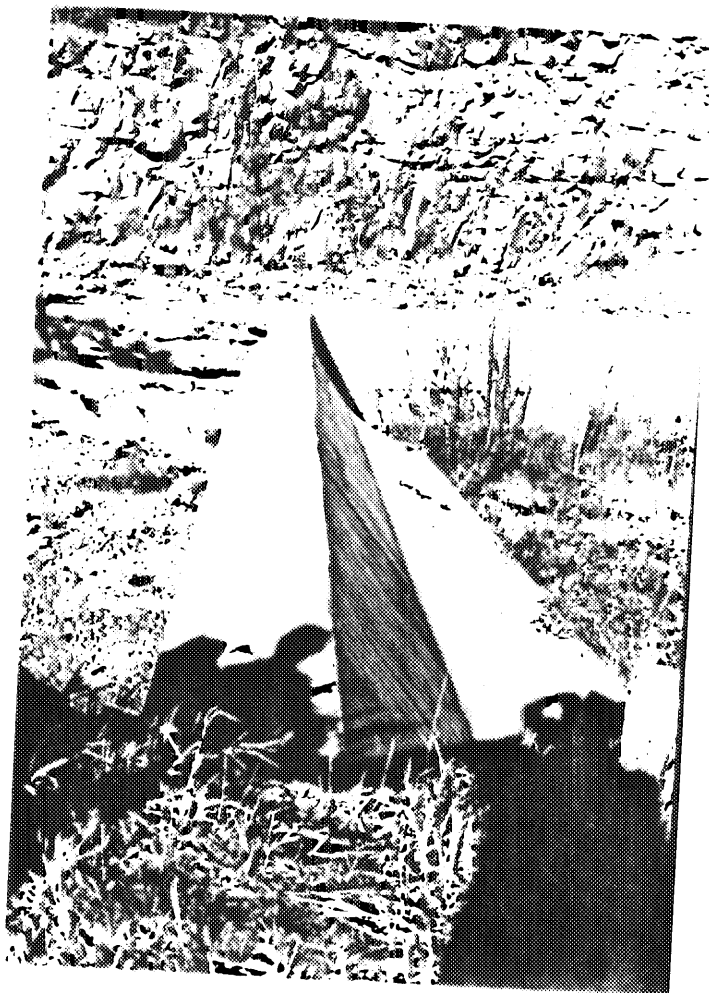
The present auxiliary spillway channel was originally the main spillway channel when the dam was first built. At the weir this channel is also in bedrock, but some distance below the weir it was excavated in earth and riprapped. The riprap has evidently not been maintained recently. The auxiliary spillway weir is in good condition (Appendix C, Photo No. 5).

5. Auxiliary spillway from left end of embankment.

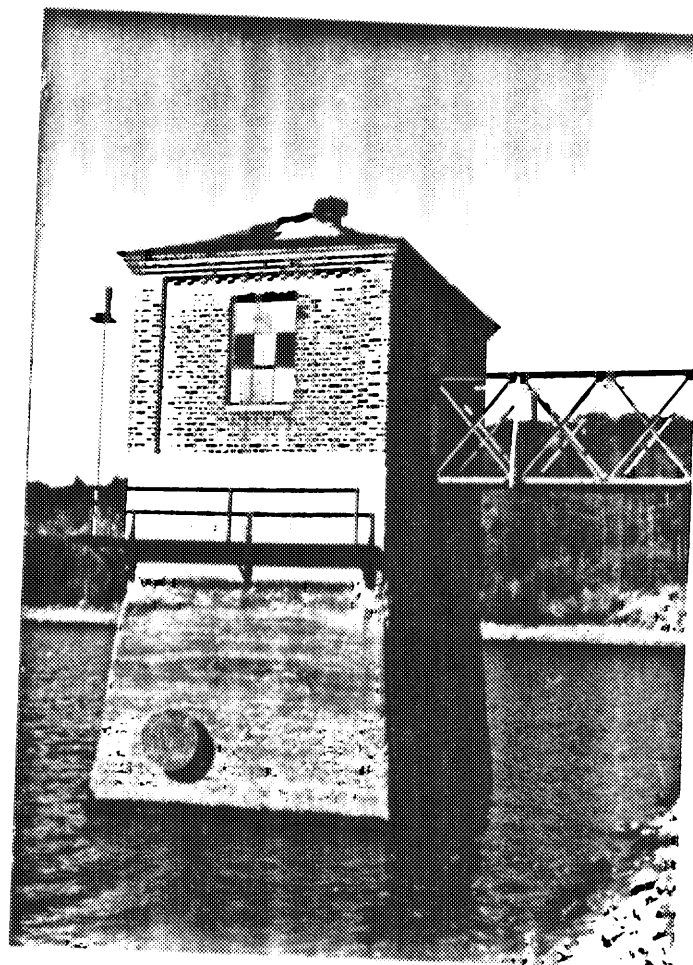
The intake tower is a concrete wet well shaft with three selective level inlet pipes controlled by slide gates (Appendix C, Photo No. 6). Two 18 in. dia. outlet pipes and a 6 in. dia. waste pipe are connected to the tower at approximately original ground level. A brick gatehouse contains the manual gate controls and is connected to the crest of the dam by a bridge. The concrete is in fair condition with some minor cracks and spalling noted. A portion of the roofing requires repair. The gates were not operated during the inspection, but according to Water Company staff all of them are serviceable.

Concrete tower shows some spalling and minor crack-
ing. Roof shingles missing on right side.

6. Outlet tower and gate house.
